ANYTHING BUT AVERAGE

Force 7

OCTOBER 1982

"Anything But Average" is the official publication of the "Leyland P76 Owners Club". It is not for sale to the general public. One copy per quarter is included in the Club annual membership fee.

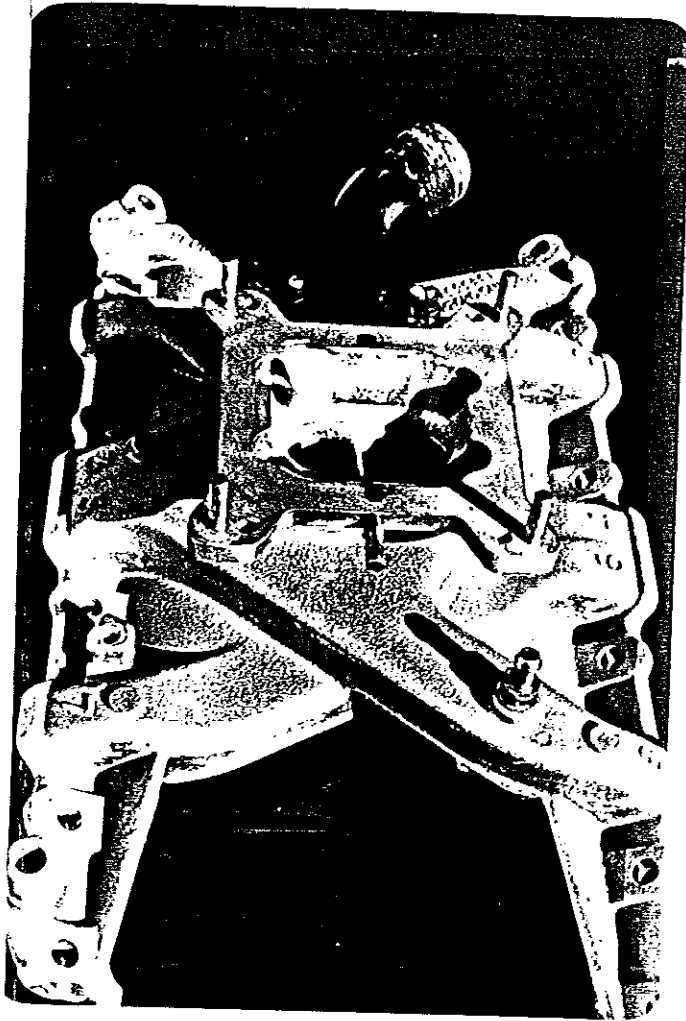
Fig.'I' 4 BARREL TO WW SPECO ADAPTER
MOD. FOR PVC CONNECTION &
SOME INTERNAL GRINDING

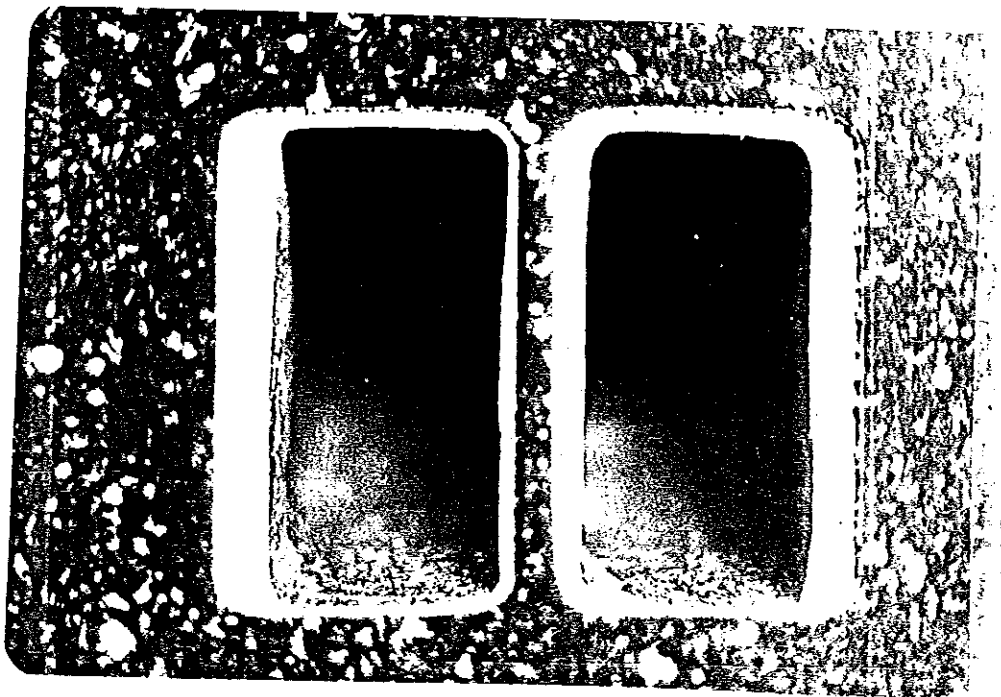
Fig.'A' STD. INLET MANIFOLD PORTS

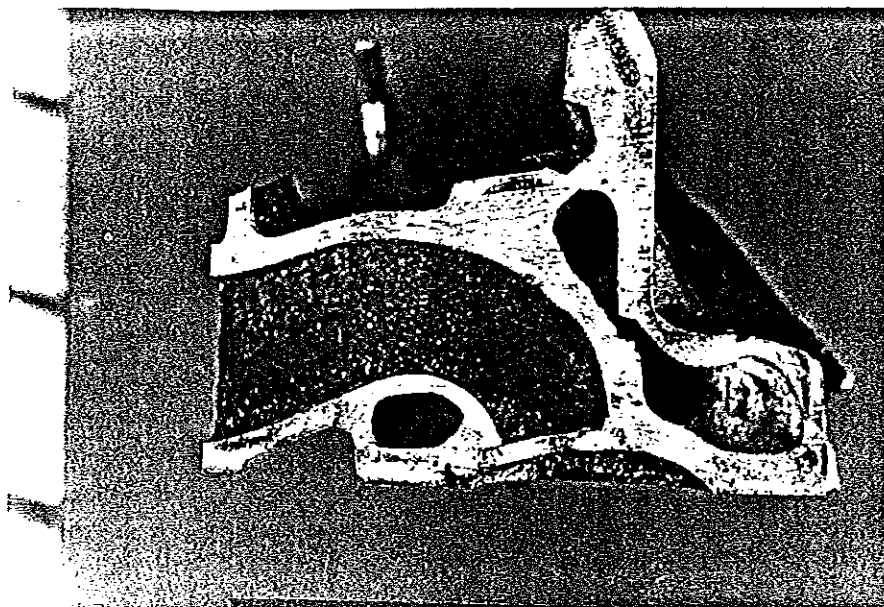
Fig. 'C' V8 INLET PORT

Right! To begin, an unusable head was disected to see what the inlet and exhaust ports consist of. The inlet ports as in Figure 'C' proved to be reasonably unrestricted (note - inlet port is slightly cut off centre) and for the sake of good torque was not altered with the exception of grinding out entrance to gasket size. Please note there was no attempt to polish any portion of the inlet ports as I believe it to be a waste of time and reduces torque produced by motor. The inlet manifold had its ports ground out to gasket size at the gasket face only (again no polishing), see Figure 'A' showing manifold as standard and Figure 'B' for manifold ports after enlargement. The Holley 350 is mounted via an adapter with no enlarging of manifold in that area.

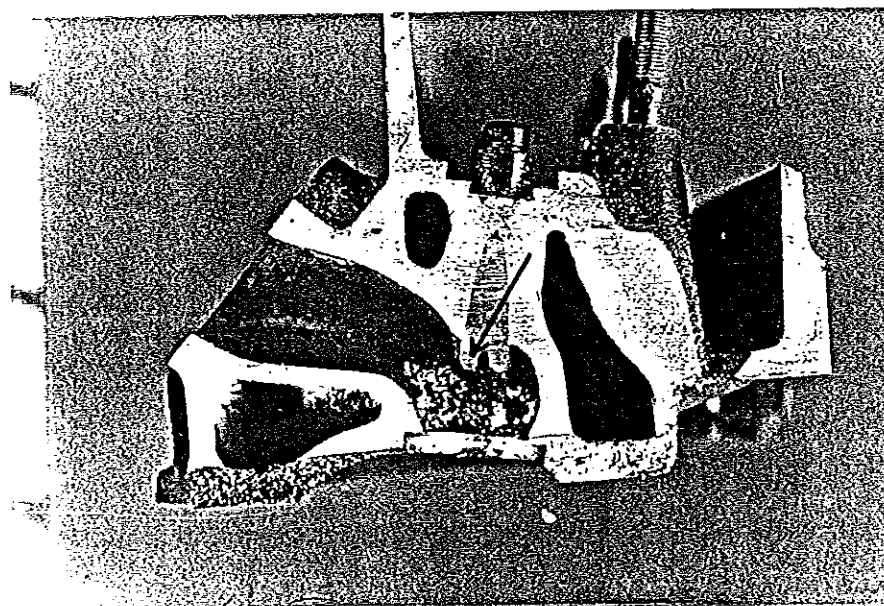
Fig. 'D' V8 EXHAUST PORT

The exhaust ports were another story, see Figure 'D' and not that the arrow points to the largest restriction for exhaust gases, the valve guide. The restriction is that bad it's not possible to get your small finger by it. The solution was to remove them by shortening the guides to 2 5/16". (The port end of the guide is cut square).

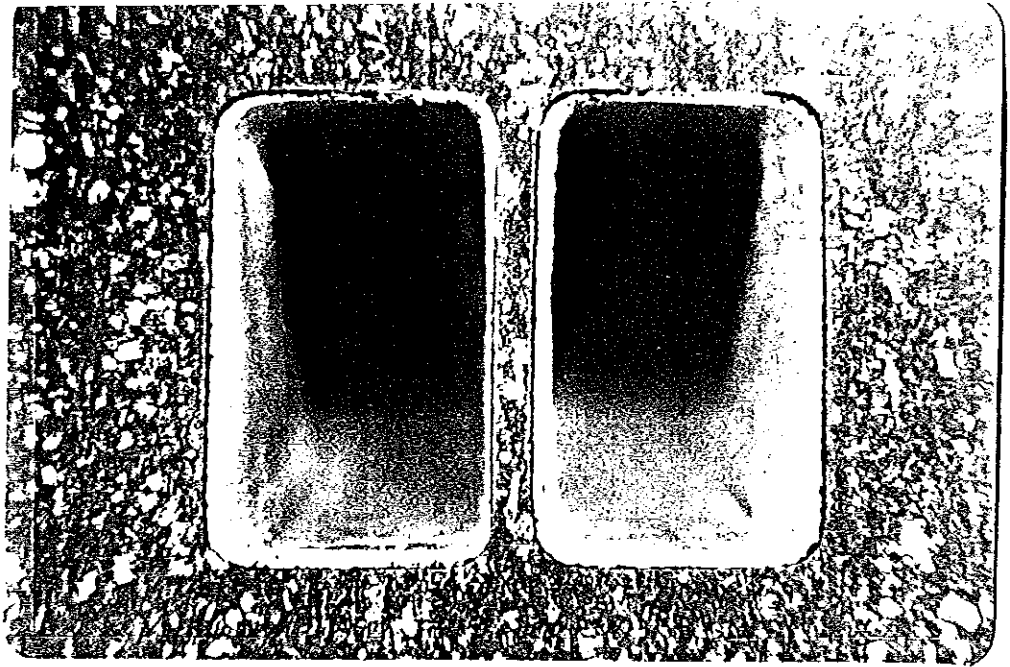
Fig. 'B' INLET MANIFOLD PORTS TO GASKET SIZE

Place a new gasket on to face of manifold or head, aligning bolt holes to properly position gasket then mark inside port holes with sharp texta or similar to show how far to grind out. I found very sharp files did a better job than using a power rasp, time being the only disadvantage.

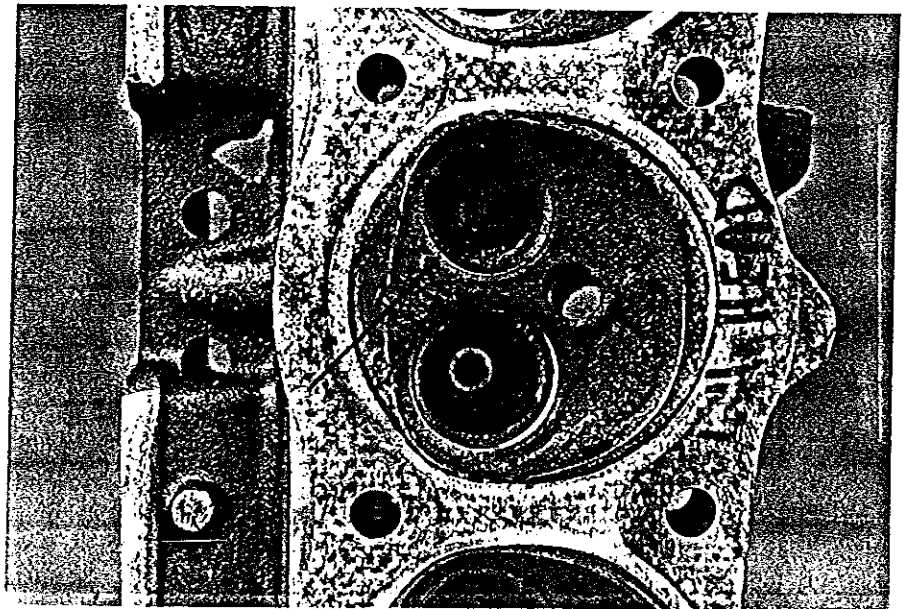
Fig. 'E' SHOWING WHERE TO UNSHROUD CHAMBERS

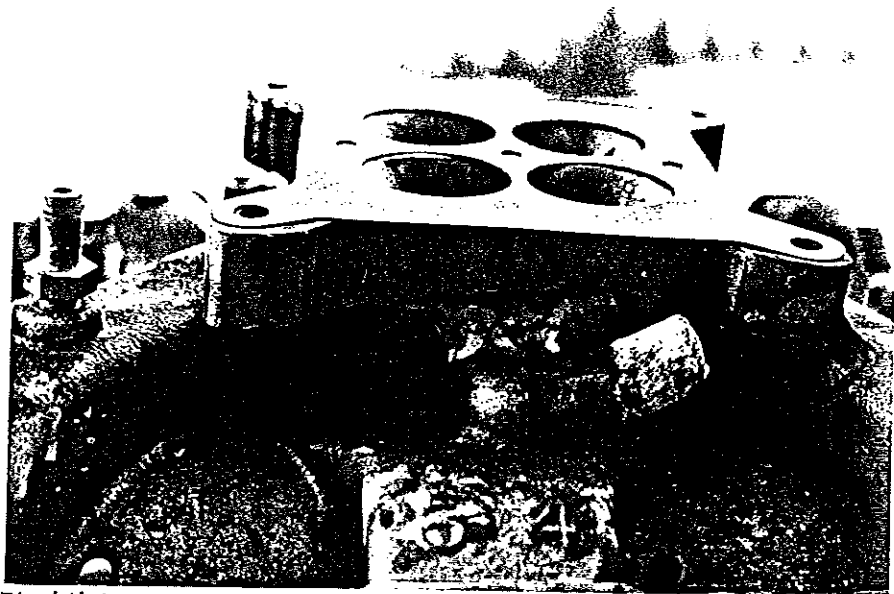
Fig. 'J' HOLLEY PLATE WELDED TO GROUND OFF STD. MANIFOLD

Not much progress in this area, the heads will be basically as for the super torque but with more port enlargement and polishing no valve size increase will be recommended as they come close to the cylinder bores. I am assured that standard valves will flow 340 H.P. with port mods. I have modified a 2 barrel manifold by cutting out a six inch square hole from the centre right through from top to bottom to expose all ports into one huge hole. A plate will be welded on the bottom and the water heating has been removed from the bottom of the manifold. Fuel distribution to cylinders may turn out to be a problem but only time will tell. On top is welded a one inch plate cut to holley four barrel pattern.

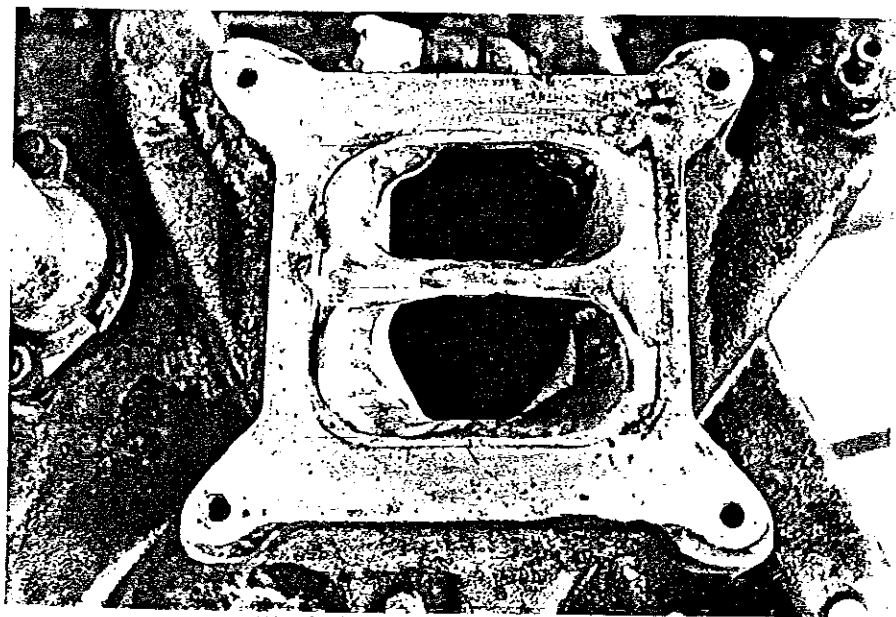
Fig. 'K' DOWN VIEW OF Fig. 'J'

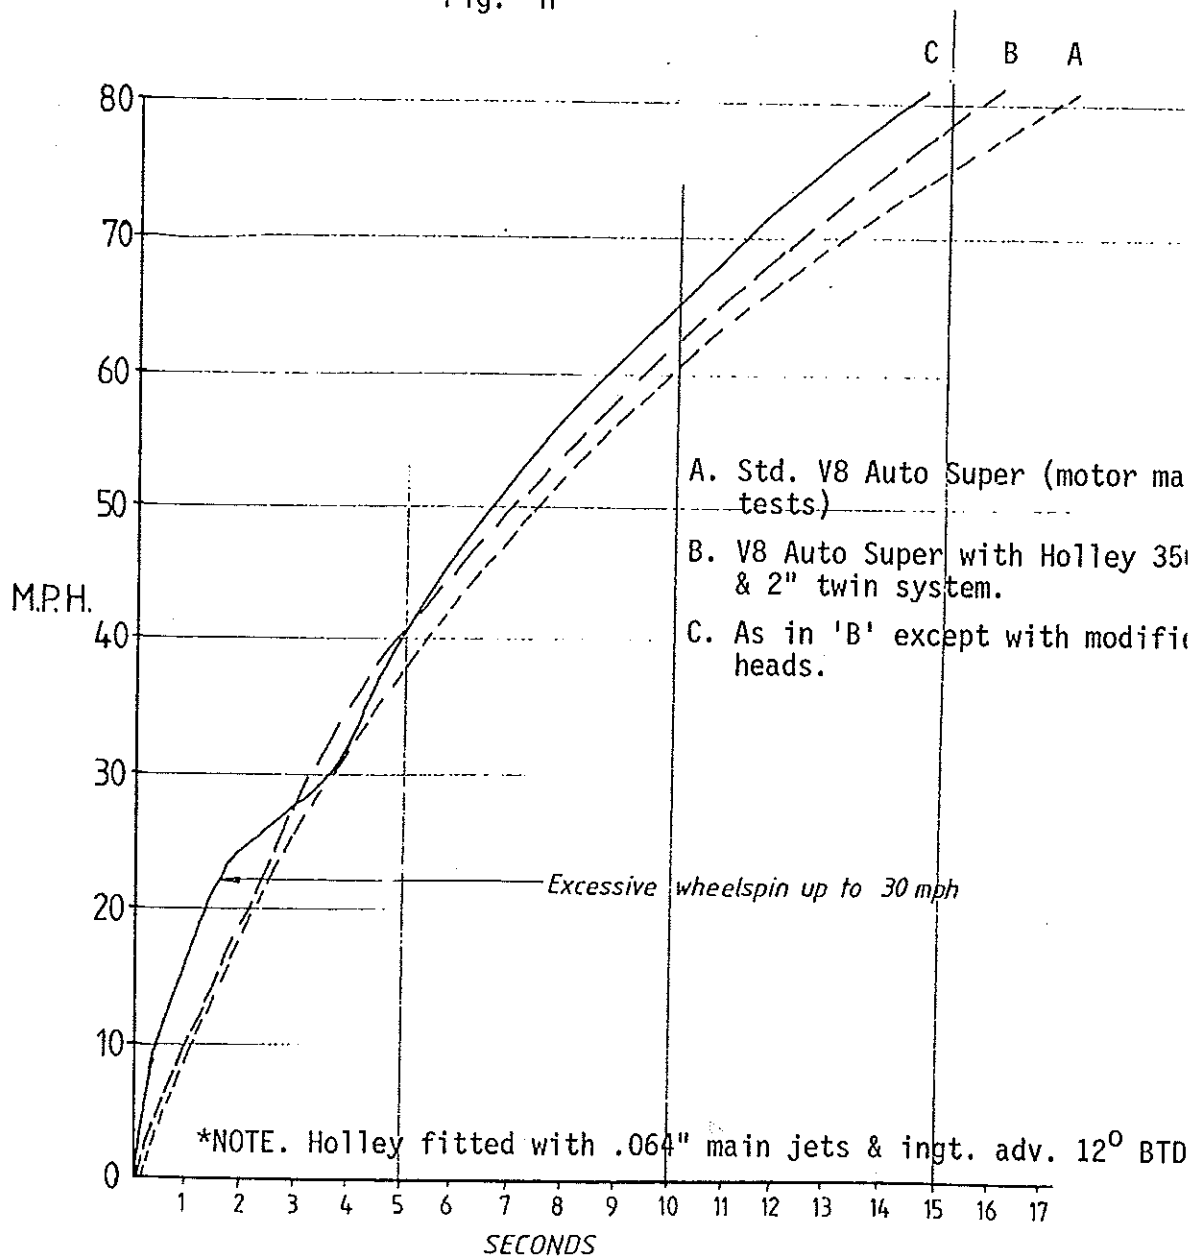
Fig. 'H'

Vehicle - V8 AUTO SUPER, (RRE-257), 90,000 + Miles,
½ tank petrol, 17°C, dry bitumen, left in
drive for all figures (no manual shifting).

So that's it for the super torque heads, in summary this is a list of mods as the vehicle runs in graph 'C'.

1. Holley 350 two barrel via adapter with .064" main jets.
2. Twin 2" exhaust with balance pipe and STD manifolds.
3. Ignition advanced 12° BTDC.
4. Compression ratio raised to 9.75:1 (heads shaved .040")
5. Exhaust valve radiused.
6. Exhaust valve guide removed from port.
7. Valves unshrouded slightly in chambers.
8. Inlet ports at gasket sizes at faces only.

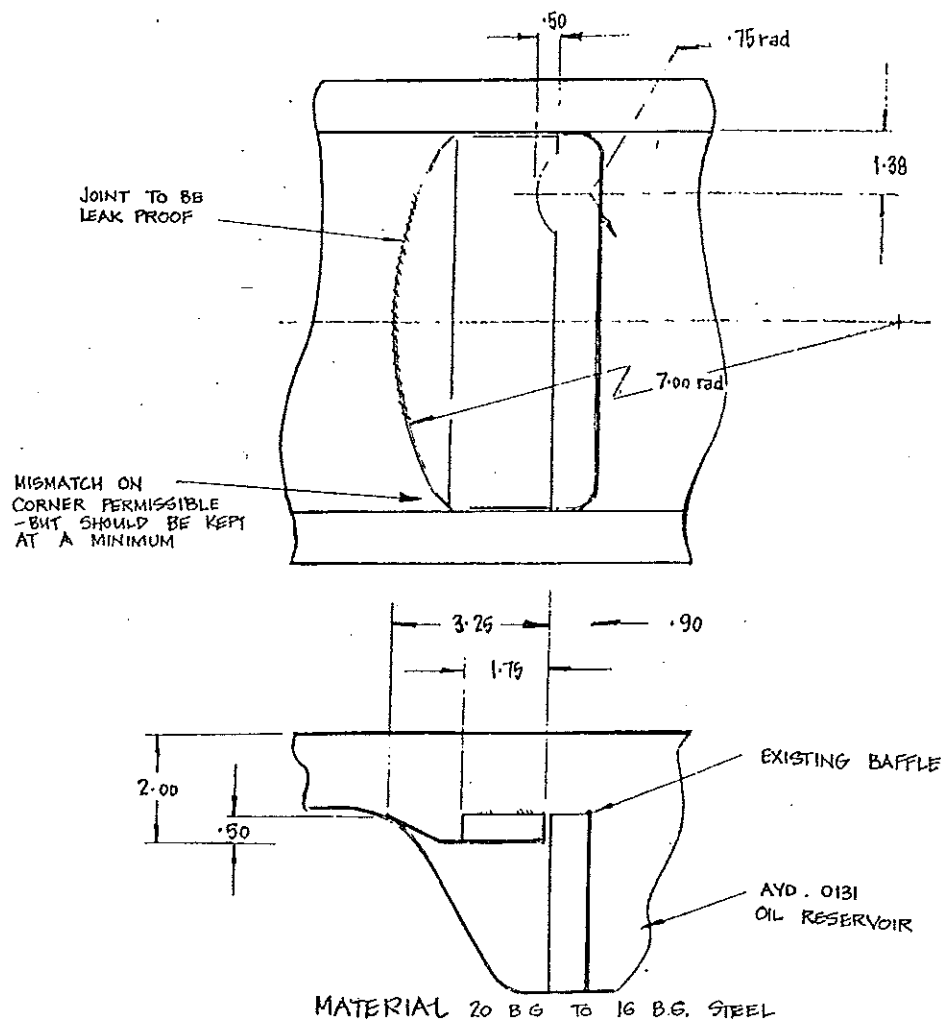
This problem can be rectified by manufacture and fitting of a reservoir baffle as shown in the attached drawing. In addition, vehicles having engines prior to the numbers listed below, should be fitted with oil pickup assembly Part No. AYD 0253.

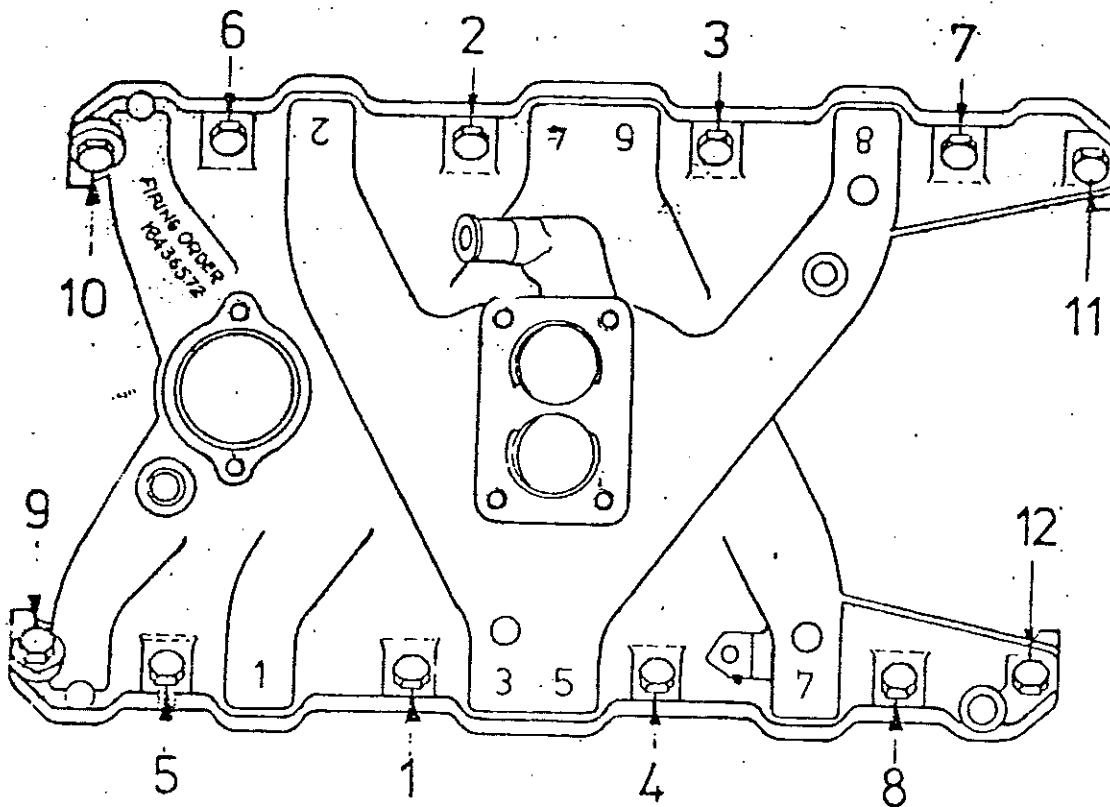
Fig. 1

When investigating manifold gasket failure or poor idling on V8 engines it is imperative that the manifold retaining bolts be checked for length. There should be ten 1 1/2" x 3/8" and two 2" x 3/8" bolts at points 9 and 10 in Fig. 1. Instances of 1 3/4" bolts being used instead of 1 1/2" bolts have been reported. These can bottom on the threads and not fully clamp the gasket.

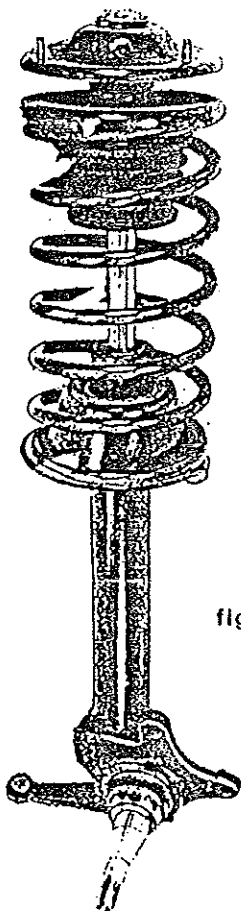
fig 1

1. You can replace those worn struts with bright shining new units at a cost of \$203.48 plus 20% sales tax each as shown in figure one.
2. A repair kit part No. HYL-4755 is available from Sydney parts priced at \$36.98 plus 20% sales tax each, and anyone with a small amount of mechanical skill following the instructions as laid down in the service manual should be able to repair the shock absorber section (Fig. 2) without a great deal of trouble.

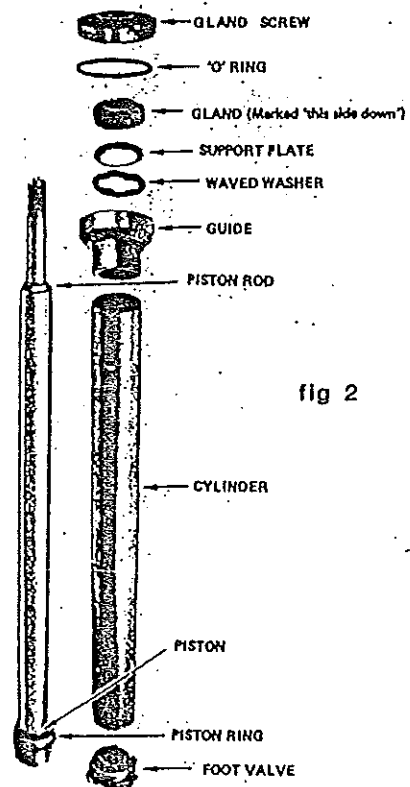
fig 2

Exploded View of Shock Absorber Components

All those parts shown in figure 2 on the previous page are replaced by one simple replacement cartrige by following the procedure set out below.

Now remove all those items shown in figure 2 drip in the GTC 600 cartridge and tighten the lock nut securely. Reassemble and install back on the car in the reverse order of disassemble and removal. Consult your work manual for the basic removal and refit procedure if you are in any doubt.

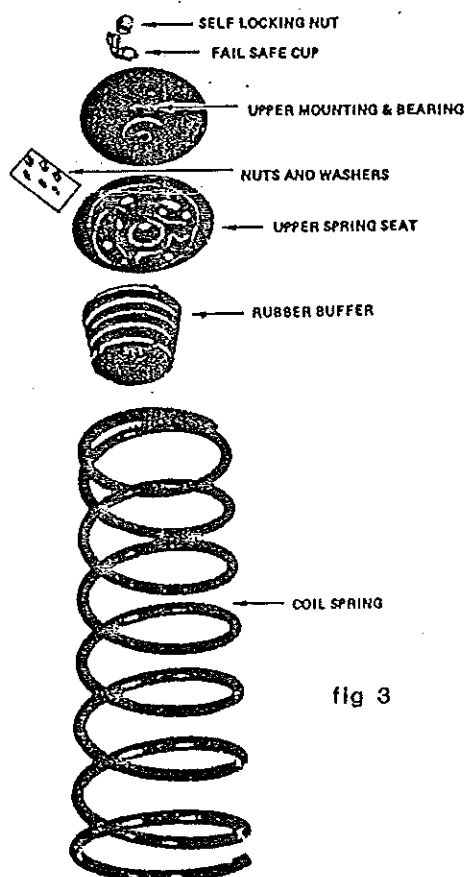
fig 3

Raise the front end and place safety stands under the chassis members. Check the rear wheels first. Remove the road wheels, disc brake caliper and the discs. Place a jack under the strut and compress the coil spring, when compressed install at least three clamps over the coils to keep them in a compressed position for later removal. Disconnect the stailizer from the control arms, disconnect the ball joint stud from the suspension strut. Now remove the three securing nuts that hold the unit in the tower. The strut can now be removed from the vehicle and taken to a bench or similar place to be worked on. Making sure that the spring is safely compressed, undo the nyloc nut and remove those parts as shown in figure 3.
